### Magnetic Flux Leakage (MFL) Inspection System for Gas Distribution Mains: Smart Pig

#### **GAS MAIN INSPECTION**

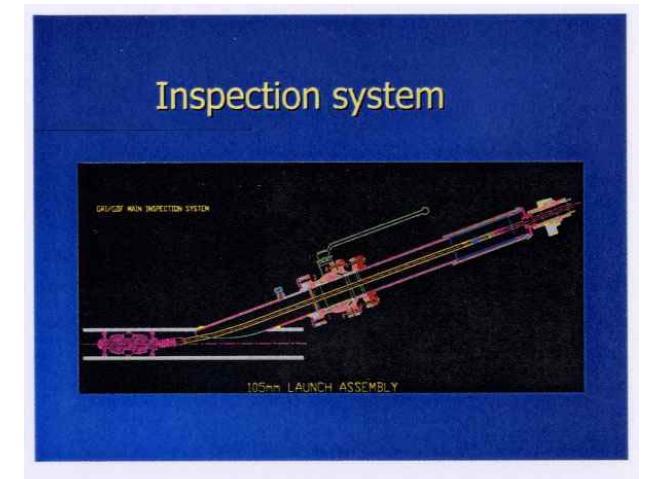
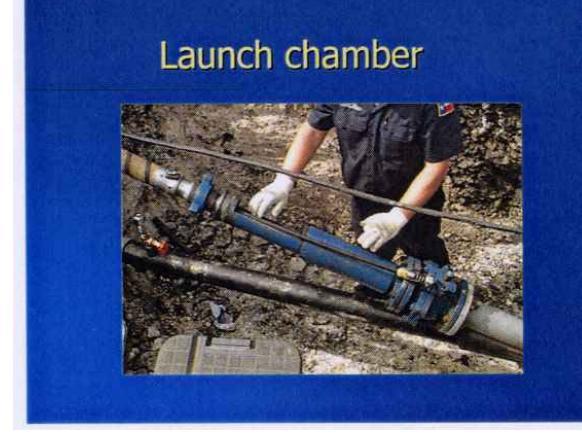
# MFL Inspection Module

- bi-directional design
- air gap around magnets length negotiates bends
- centered on flexible disks
- powerful magnets (Neodymium Iron Boron) Hall sensing elements real time processing

In order to reduce the excavation at each affected area of the pipe, an innovative and patented system *(see attached Figure)* was developed based on the well-known Magnetic Flux Leakage (MFL) technique.

- The MFL sensor --Smart Pig was attached to a mechanically driven push-rod for traveling the sensor through the mains while the gas was flowing through the pipe.
- By making one excavation and using the pioneering MFL inspection technology operators can
  inspect live gas mains, lower operating costs, minimize service disruptions, and increase safety
  and reliability.

The second challenge required miniaturization of the MFL sensor. The commercial MFL inspection pigs are quite long relative to their diameter and use stiff steel brushes to contact the pipe wall in order to assure good magnetic coupling. In gas distribution main applications, the MFL probe must be made much smaller in dimension and operate with an air gap between the magnets and the pipe wall. The MFL sensor with 32 hall sensors was designed and tested. The sensor with the air gap was manufactured to allow uninterrupted gas flow, minimize drag, and reduce the potential of introducing particles into the gas stream that could otherwise occur from the scraping **action of the brushes**.
